SAND 2000-1702
Unlimited Release
Printed August 2000

Characterization of Sidewall and Planar Surfaces of Electroformed LIGA Parts

Somuri V. Prasad, Aaron C. Hall, and Michael T. Dugger
Interface Reliability Department
Sandia National Laboratories
P.O. Box 5800
Albuquerque, NM 87185-1407

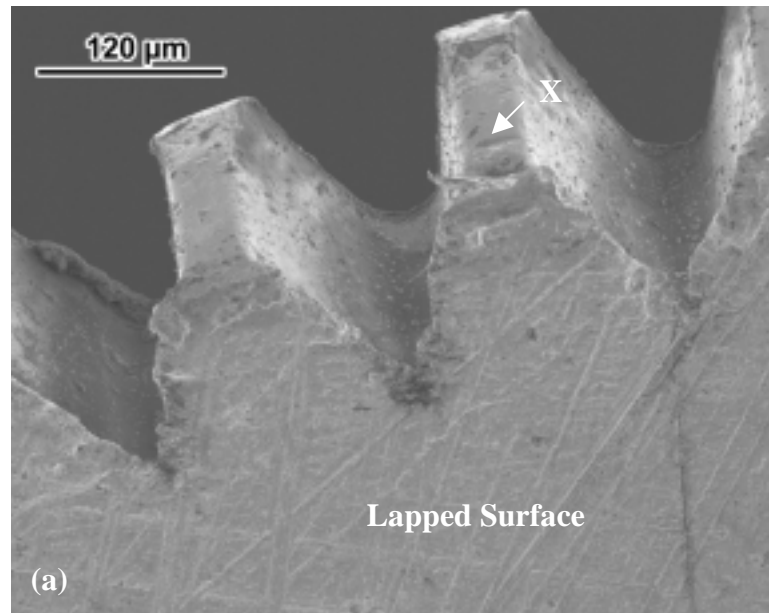
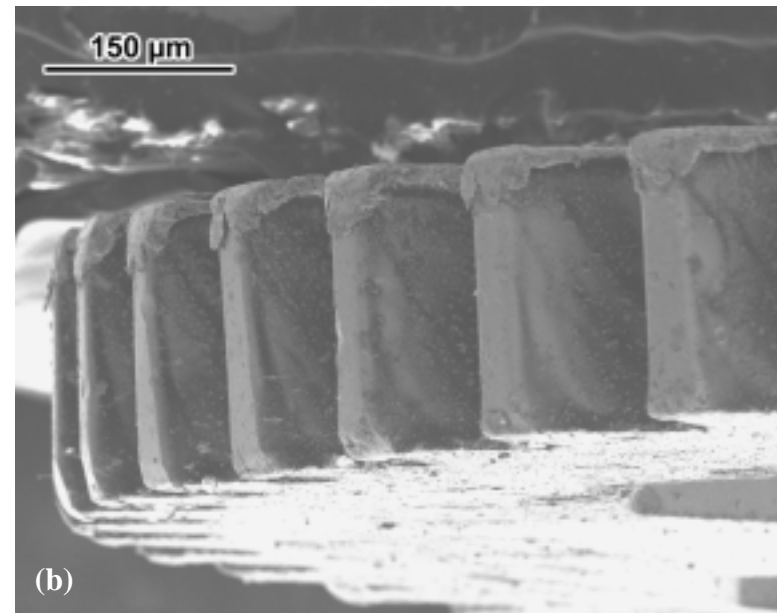
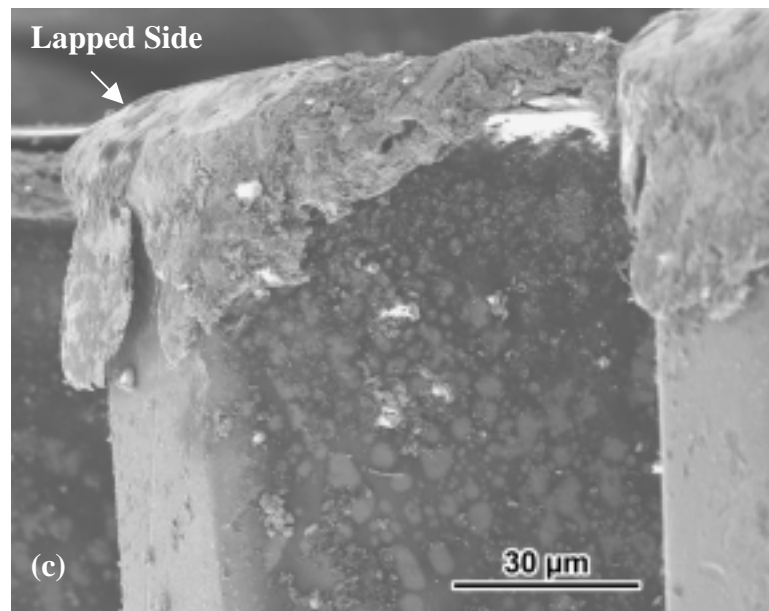
Metallographic polishing of softer metals is known to be a challenging task as there will be some stress concentration at the unsupported edges of a lapped component, e.g. gear teeth. This is clearly illustrated in the SEM micrographs of a LIGA Cu gear shown in Fig. 2. Damage to gear teeth edges is evident in Fig. 2a. Scratches are present on the lapped surface (Fig. 2a). Smearing of material on teeth edges, presumably from lapping, can be seen in Fig. 2b. Figure 2c is a higher magnification micrograph showing extensive plastic deformation of copper during lapping that actually flowed beyond the sidewall, and was probably bent down after release. Scratches seen on gear teeth at the location marked "X" in Fig. 2a were probably due to uncontrolled handling of parts prior to analysis. Edge damage to gear teeth does not appear to be a major problem in the case of LIGA Ni gears. At moderate magnifications, the lapped surface appeared to be smooth and free of scratches, as can be seen from Fig. 3b. Lapping on this particular Ni gear introduced only submicron scratches (Fig. 3b and 3c).

Fig. 2 SEM images of a LIGA Cu (CA) gear showing edge rounding (or lack of edge retention).

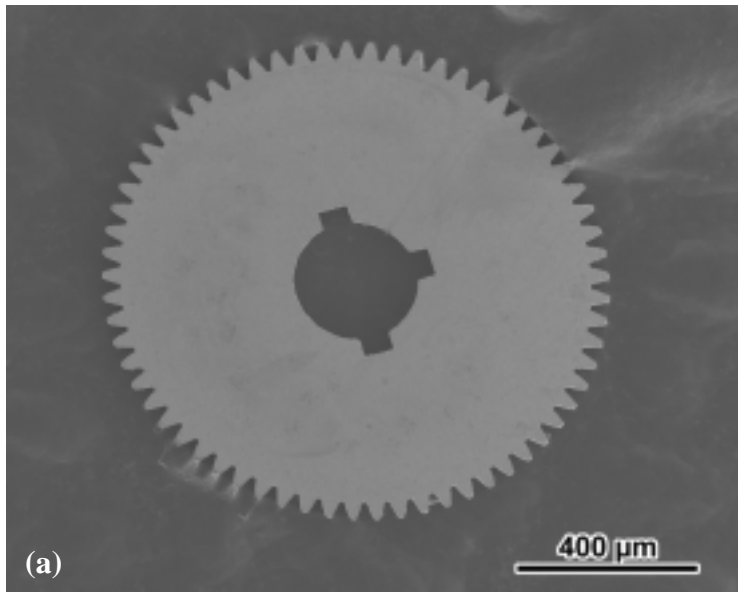
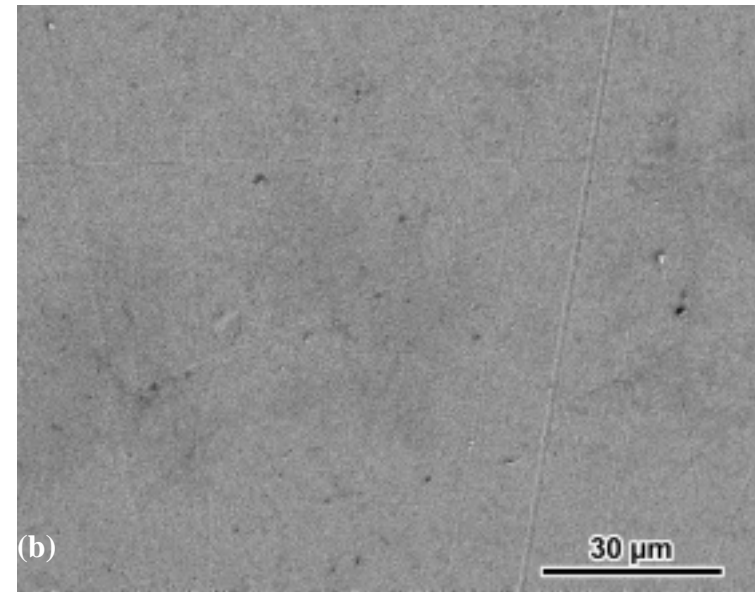
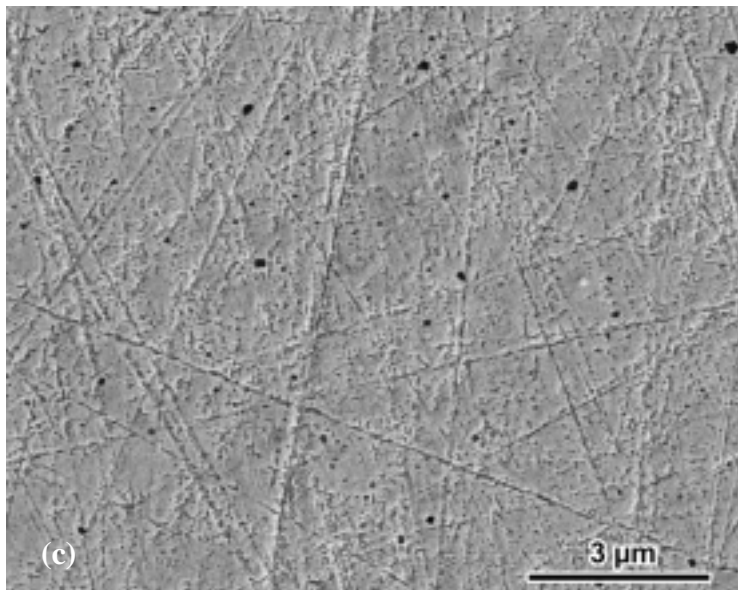
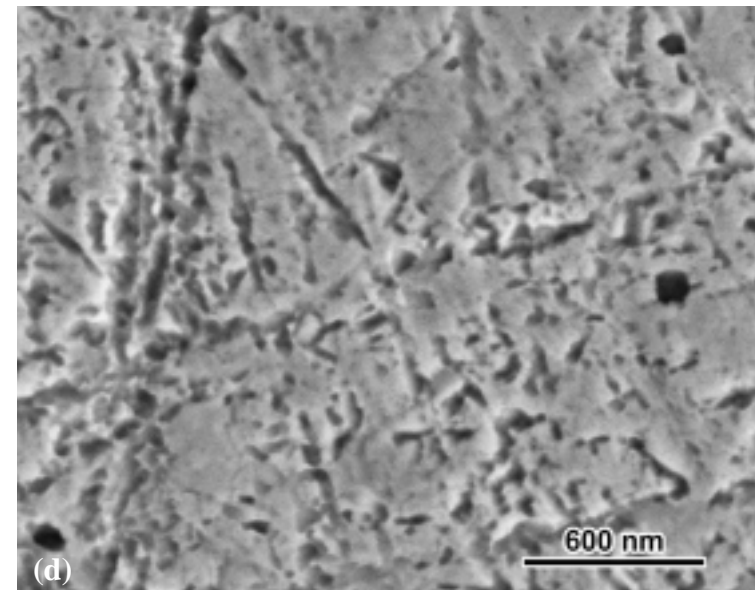
Fig. 3 Typical surface morphology of a LIGA Ni gear (NM): Lapped surface.

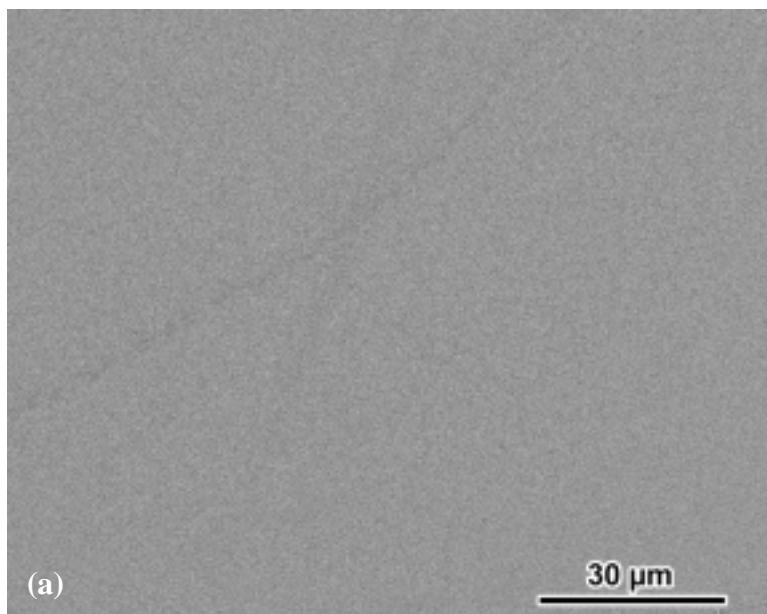
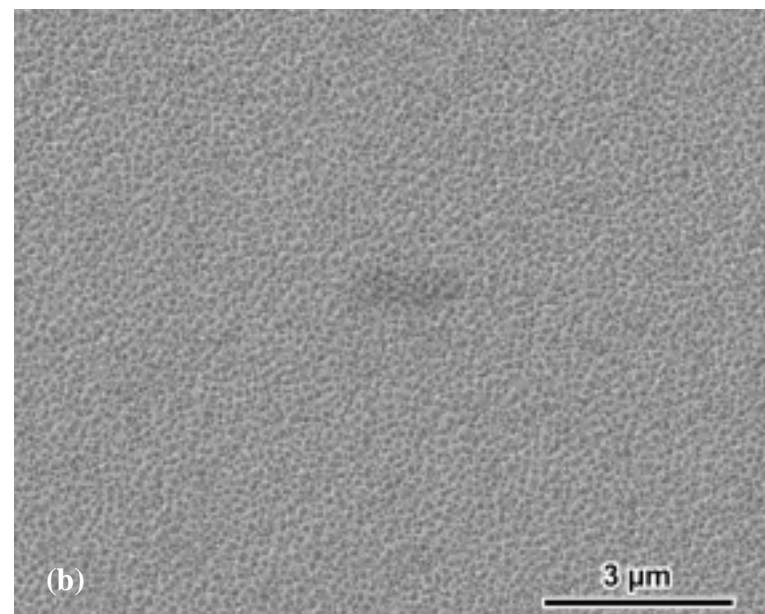
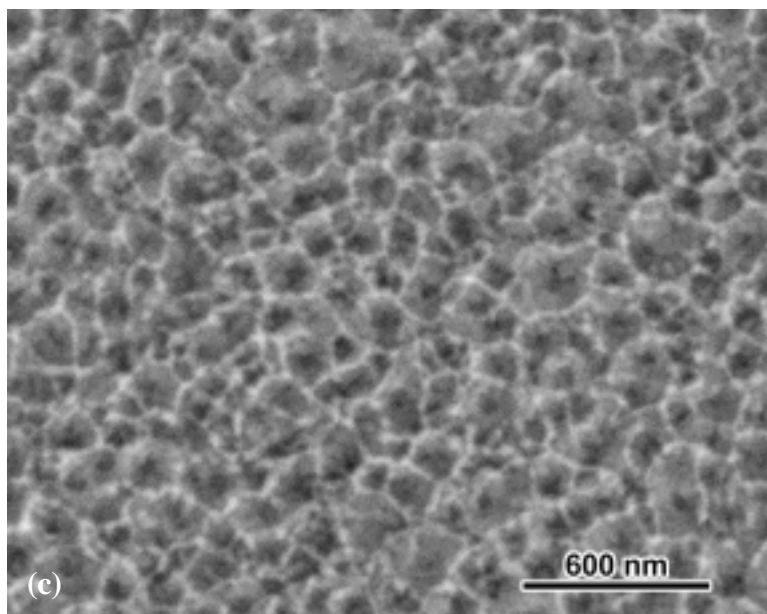
Typical SEM micrographs of a LIGA Ni gear on the release side are shown in Fig. 4. At higher magnifications, the surface revealed a honeycomb type of granular structure with grain size in the nanometer range (Fig. 4b). SEM micrographs of the release surface of a

Fig. 4 Surface morphology on the release side: LIGA Ni gear (NM).

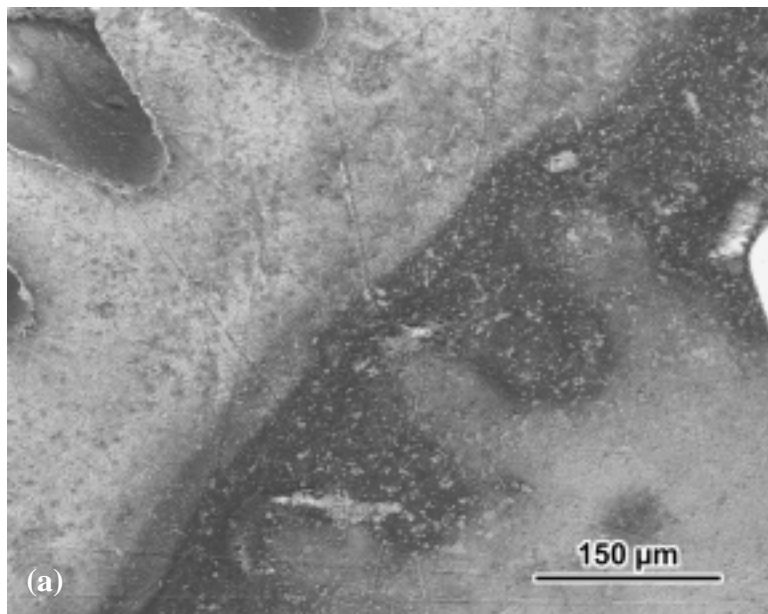
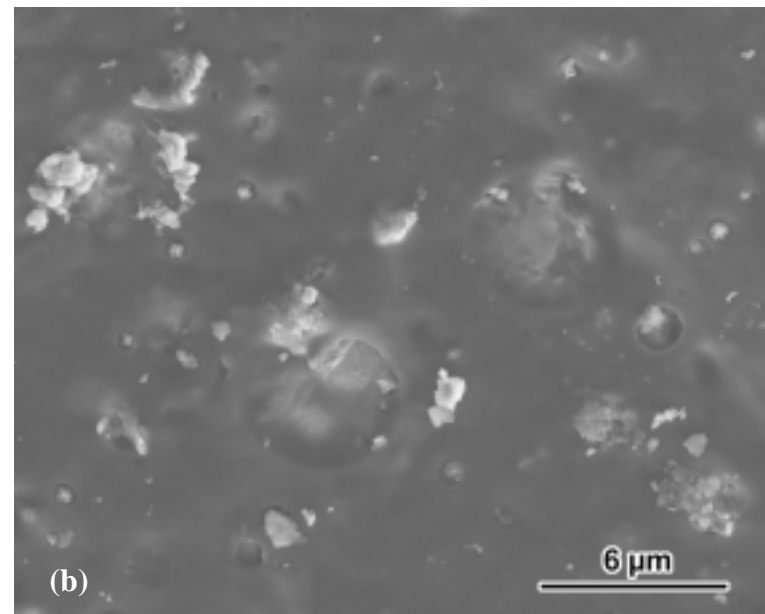
Cu gear are given in Fig. 5. It appears that a residual layer of the polymeric film was still intact on this particular surface.

Fig. 5 Surface morphology on the release side of a Cu gear (CA).

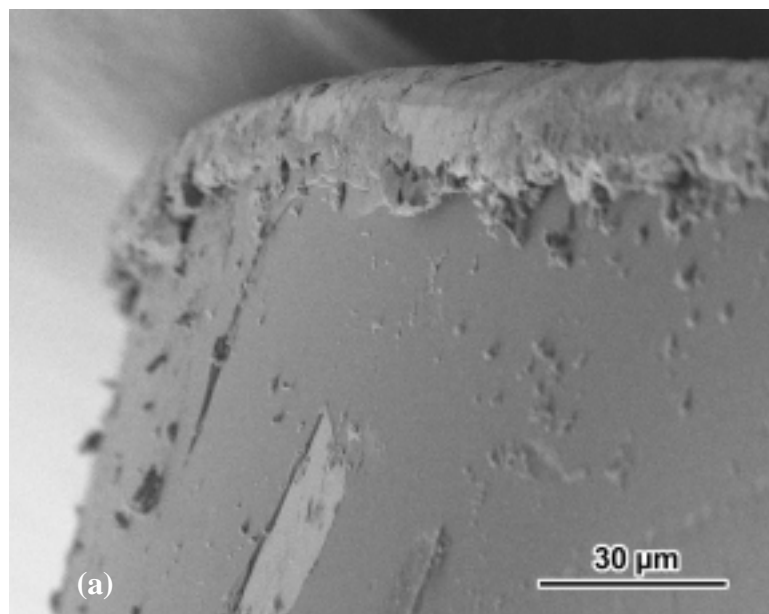
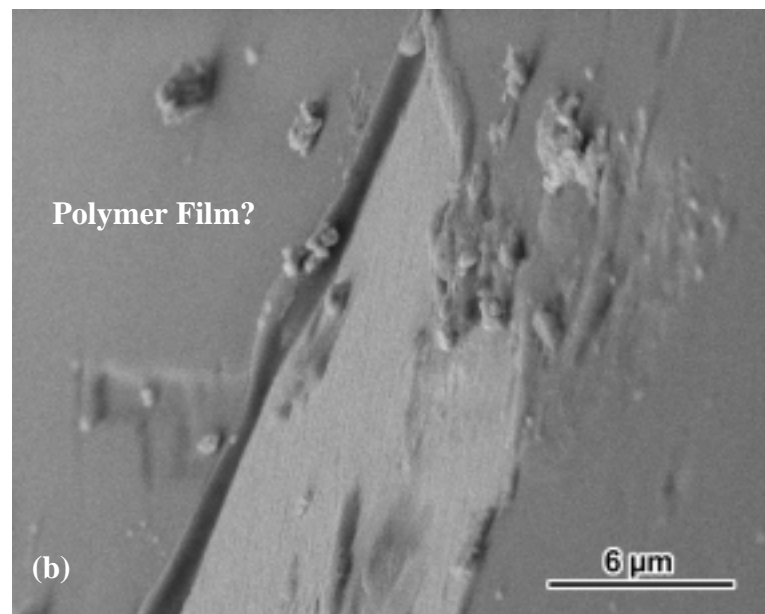
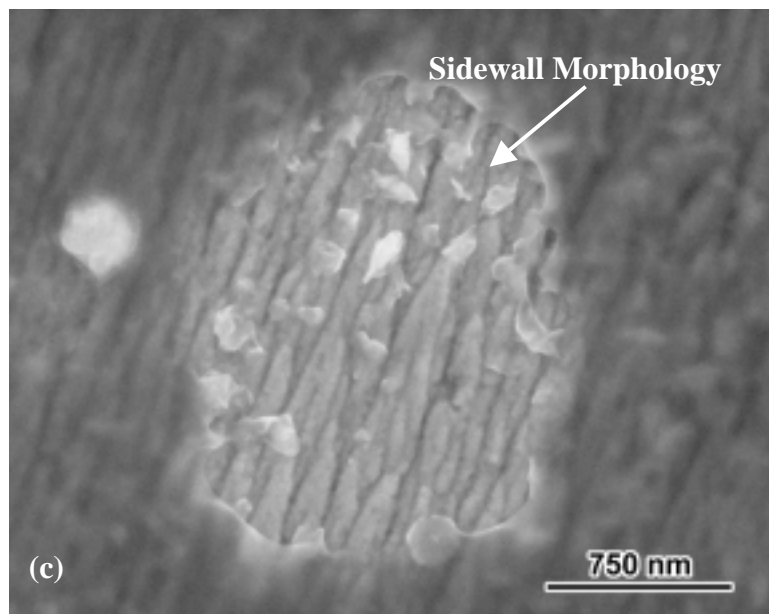
Figure 6 is a set of SEM images of a Cu part sidewall showing incomplete removal of the polymeric film. However, the patch in Fig. 6c revealed the true sidewall morphology. The parts were subjected to a release process to dissolve the PMMA material after electroforming and lapping [1]. Issues such as incomplete removal of the mold material from narrow crevices, or redeposition after dissolution, should be addressed with researchers in process development to ensure that surfaces are clean enough to accept a coating.

Fig. 6 SEM images showing incomplete removal of polymer film on the sidewall of a LIGA Cu gear (CA). True sidewall morphology can be seen in the patch in Fig. (c).

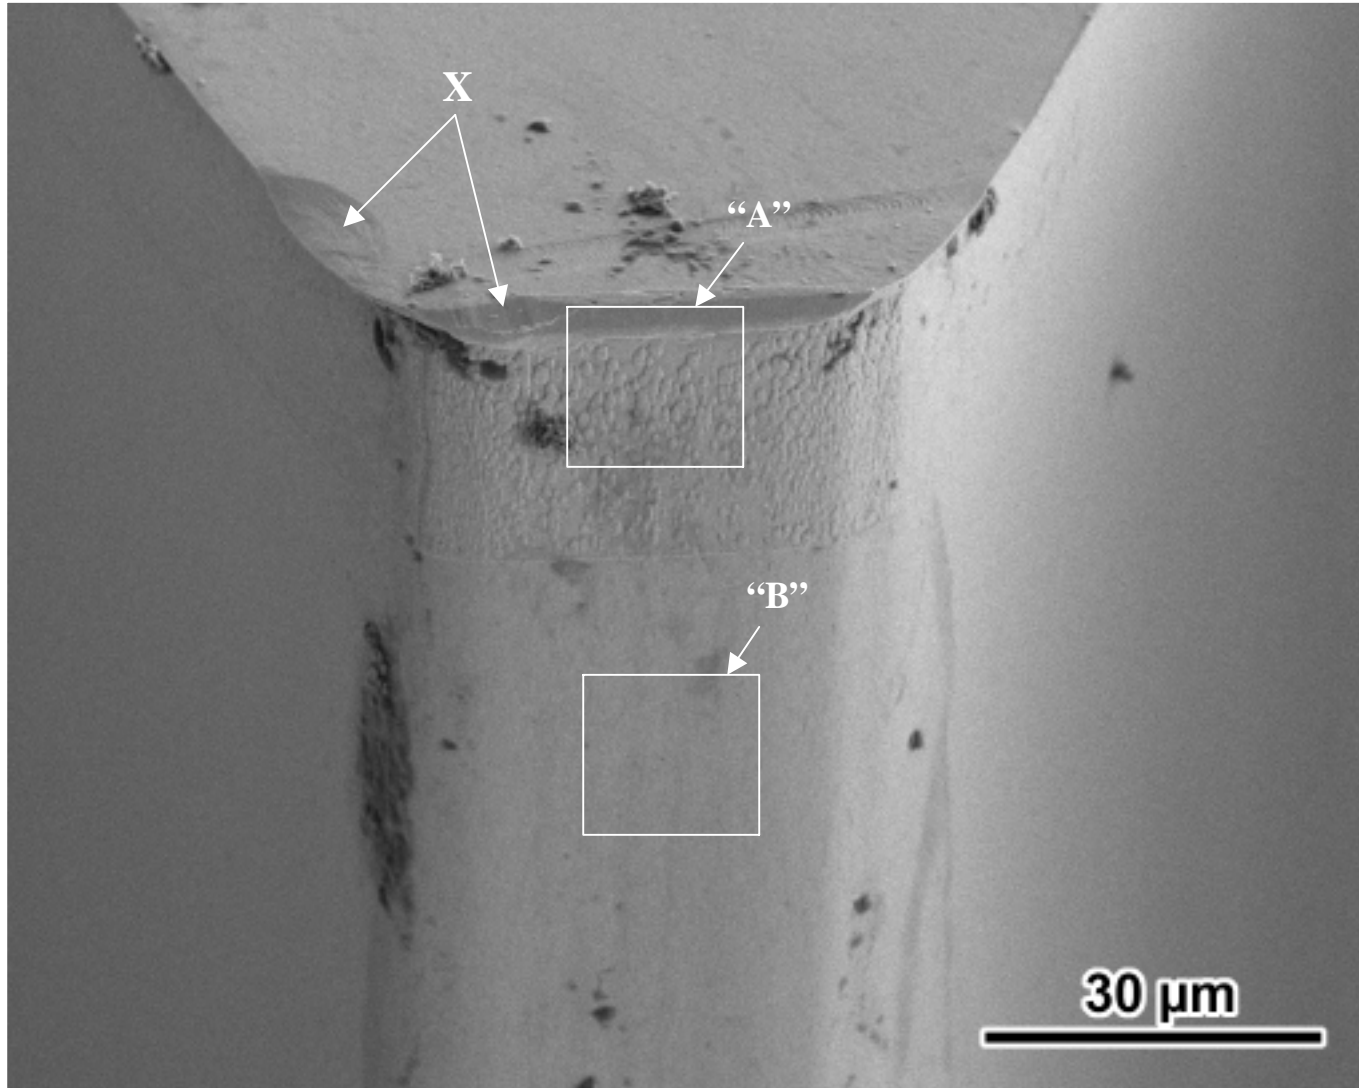
An SEM micrograph of a LIGA Ni gear sidewall is shown in Fig. 7. The damage seen at locations marked "X" in Fig. 7 was probably caused by handling of parts prior to analysis. The top is the lapped side showing minor damage to the tooth edge. Higher magnification images of the regions marked "A" and "B" are shown in Fig. 8. There is a blister-like morphology at the top of the gear tooth. The middle is more like a columnar structure (Fig. 8b). The microstructure of electroformed Ni is typically columnar in nature. For instance, earlier work by Buchheit and coworkers [2,3] in this laboratory showed that LIGA Ni has a (100) texture, i.e., (100) crystal orientations are nearly parallel to the growth direction. However, the columnar grain size determined by backscattered electron Kikuchi patterns (BEKP) in those studies [2,3] is much larger than the nanometer-size columns seen in Fig. 8b. It is very likely that the morphology seen in Fig. 8b is a surface feature resulting from the x-ray mask. Examination of mold surfaces

Fig. 7 Sidewall morphology of a Ni Gear (NM). Higher magnification images of regions marked "A" and "B" are given in Fig.7.

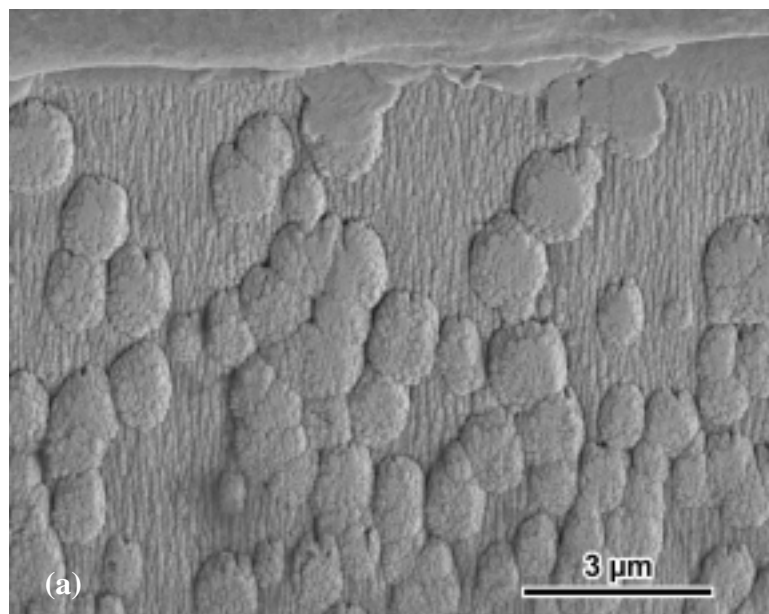
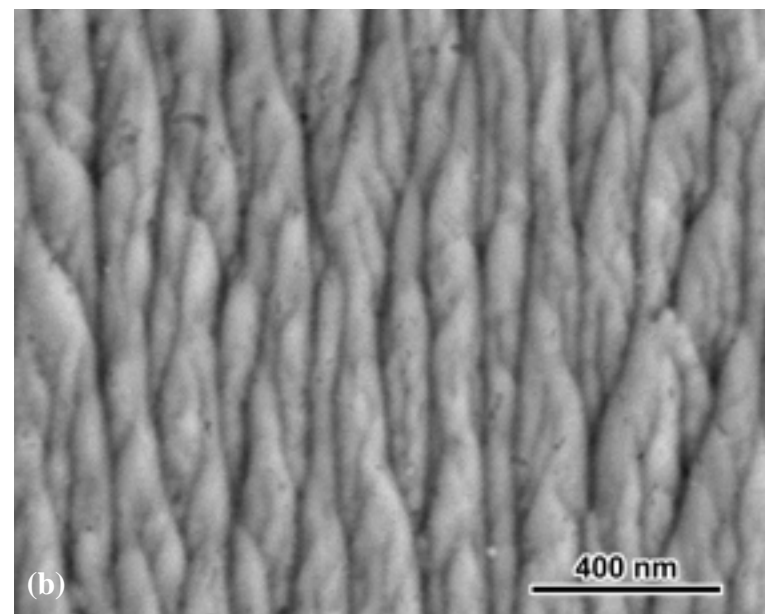
Fig. 8 Higher magnification images of sidewall morphology of a LIGA Ni gear (NM). Figure (a) corresponds to the region marked “A” in the previous figure, while Fig. (b) corresponds to the higher magnification image of the region marked “B” in Fig. 7.

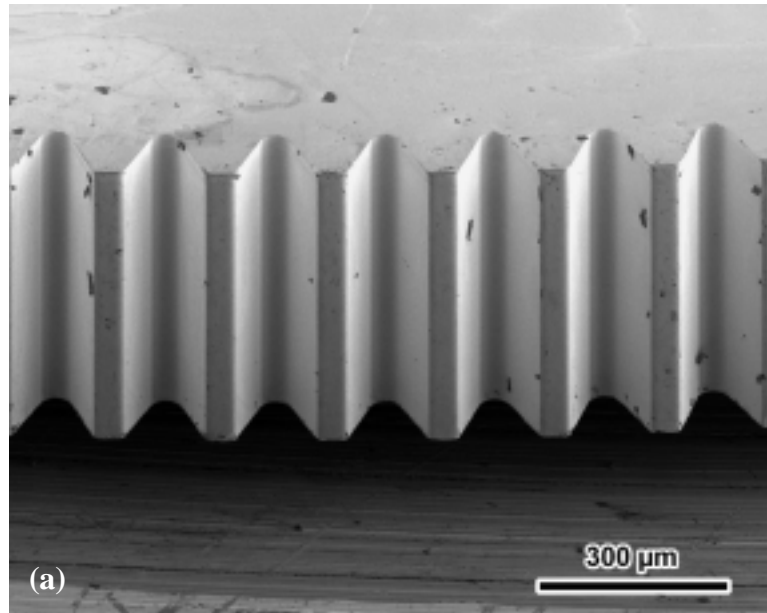
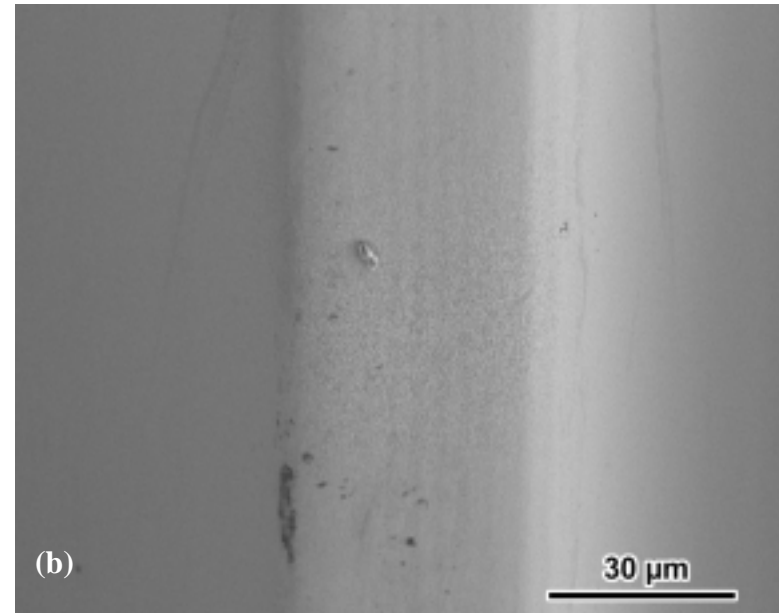
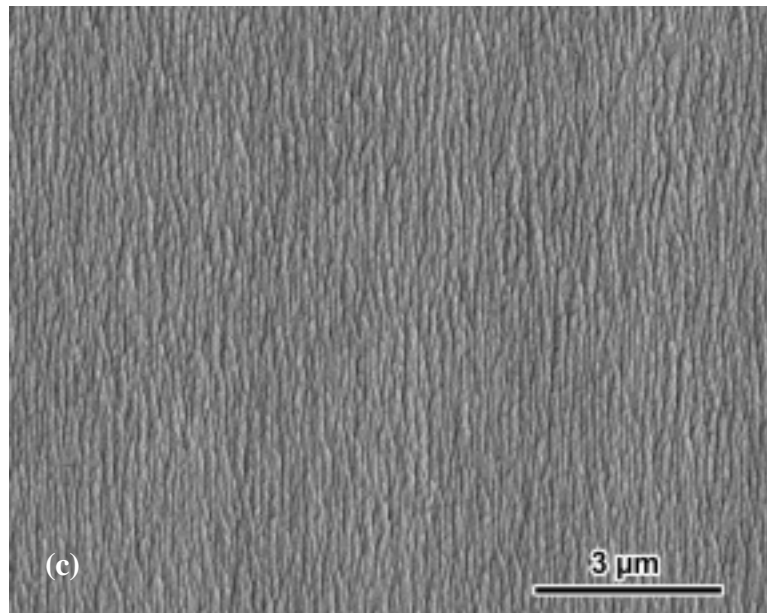
prior to plating could resolve whether the sidewall roughness is due to mold structure. SEM micrographs of another LIGA Ni gear sidewall showing essentially the same features are given in Fig. 9. The LIGA Cu gear sidewalls also showed similar morphology (Fig. 10). The root of the LIGA Ni gear showed steps at regular intervals (Fig. 11a). Similar images from another Ni part (Fig. 11 b and c) show "scales" that appear to be partially detached from the remainder of the gear tooth at one edge. Additional metallographic sectioning and analysis will be required on future samples to determine if this is the case.

Fig. 9 Sidewall morphology of another Ni Gear (NM).

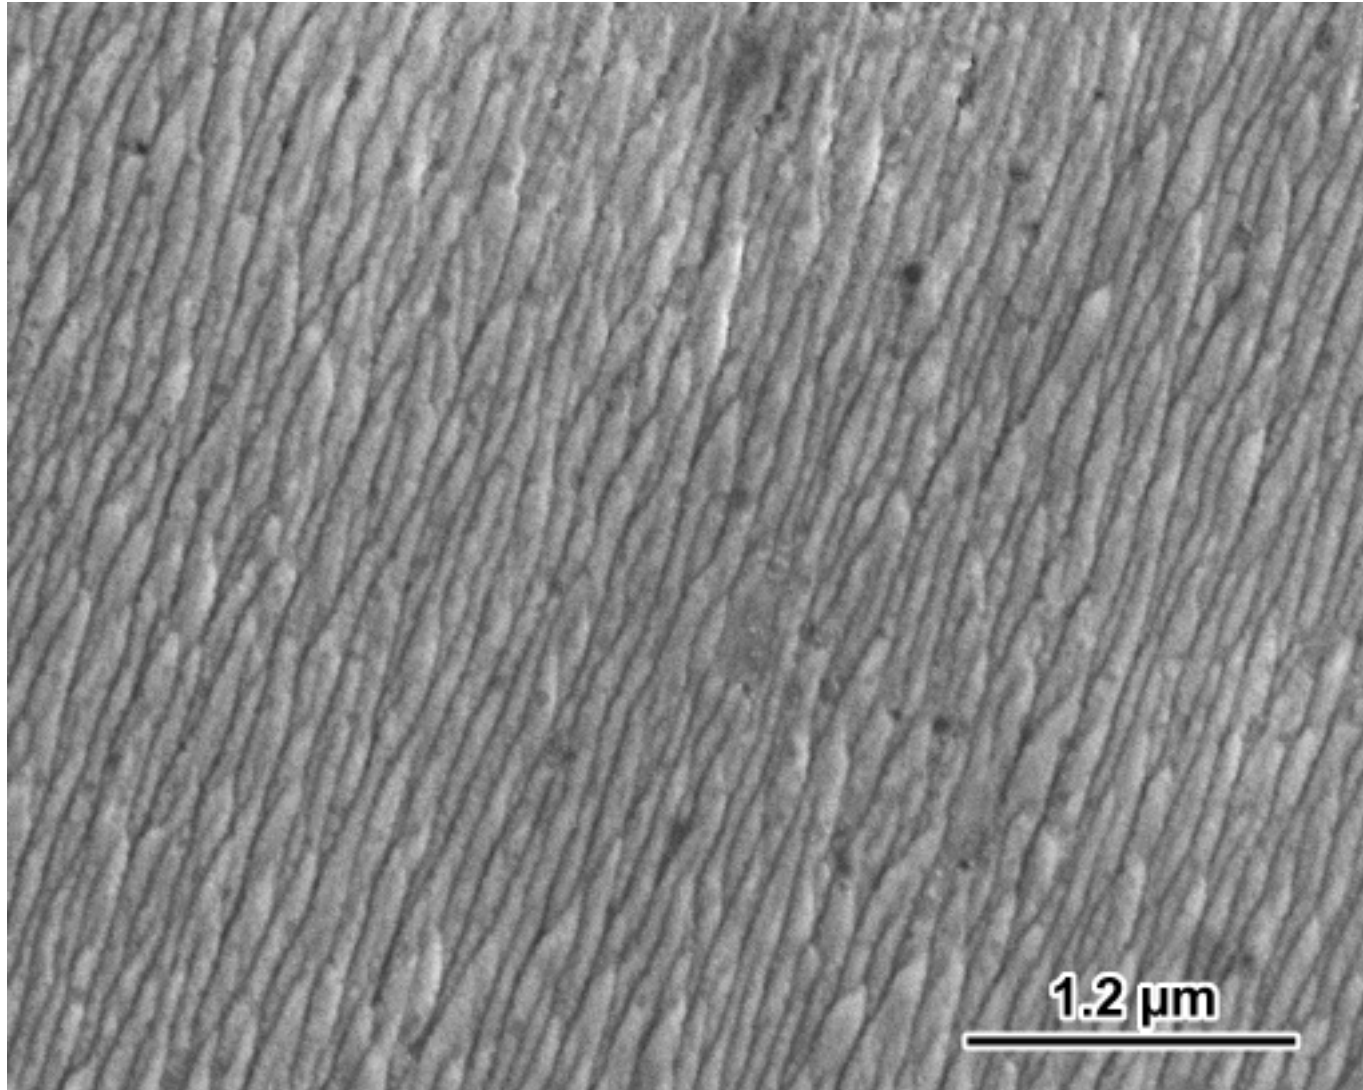
Fig. 10 Side wall morphology a LIGA Cu gear (CA).

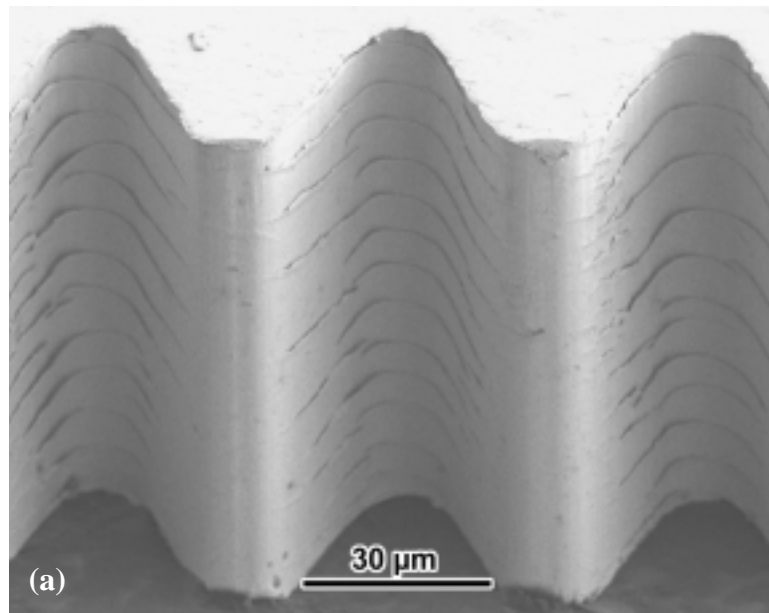
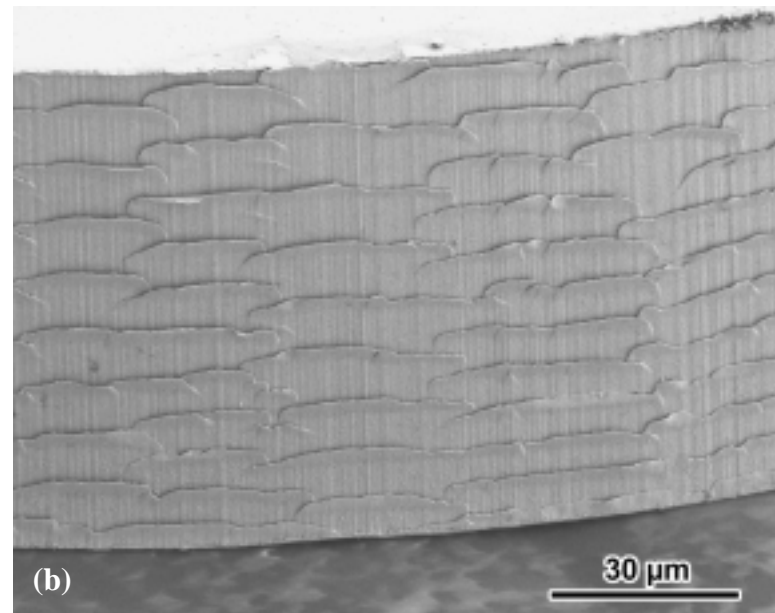
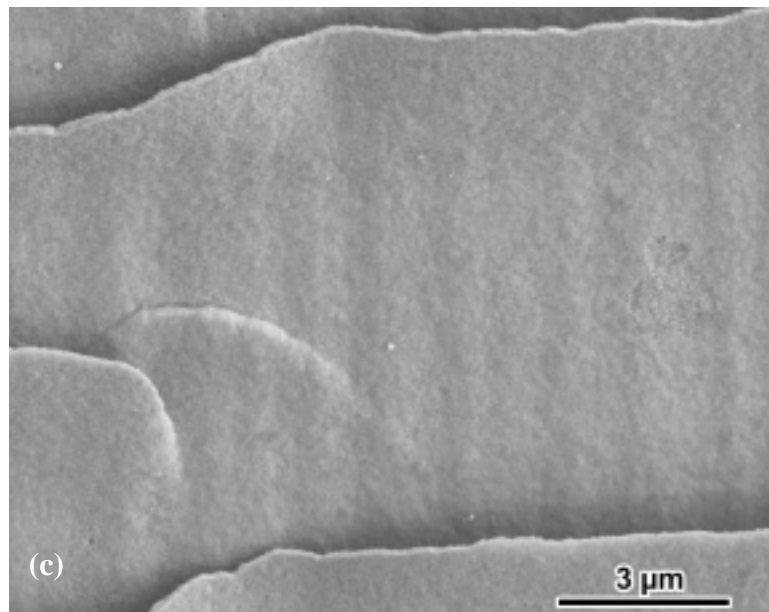
Fig. 11 (a) and (b) Sidewall morphologies of two different LIGA Ni (NM) gears; (c) higher magnification micrograph of Fig. (b).

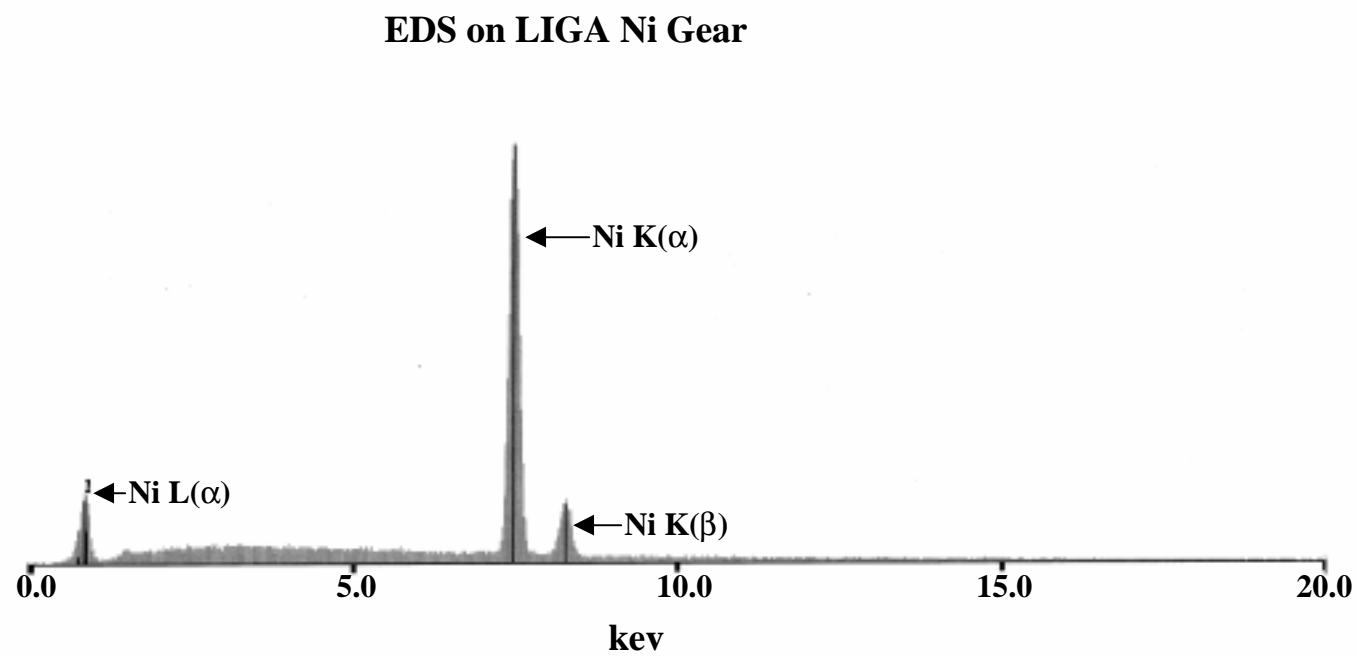
Typical energy dispersive x-ray spectra collected from Ni and Cu LIGA parts are given in Figs. 12 and 13 respectively. The spectra essentially showed no impurities. However, it is not possible to determine whether lighter elements such carbon coming from the

Fig. 12 A typical energy dispersive x-ray spectrum (EDS) collected from a LIGA Ni (NM) gear.

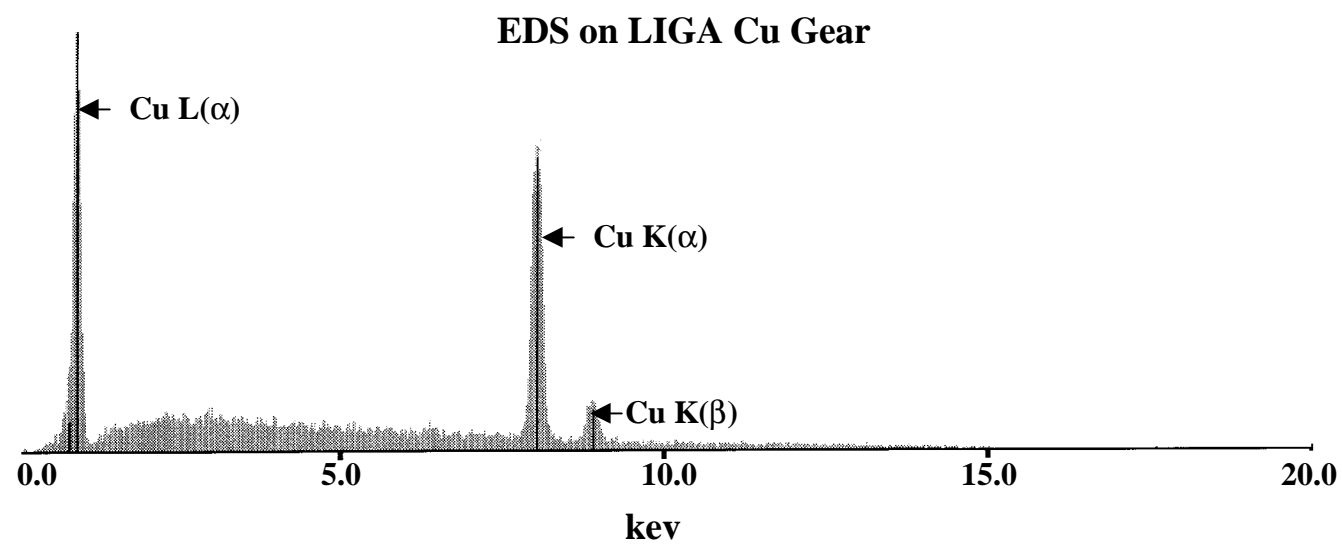
Fig. 13 A typical energy dispersive x-ray spectrum (EDS) collected from a LIGA Cu (CA) gear.

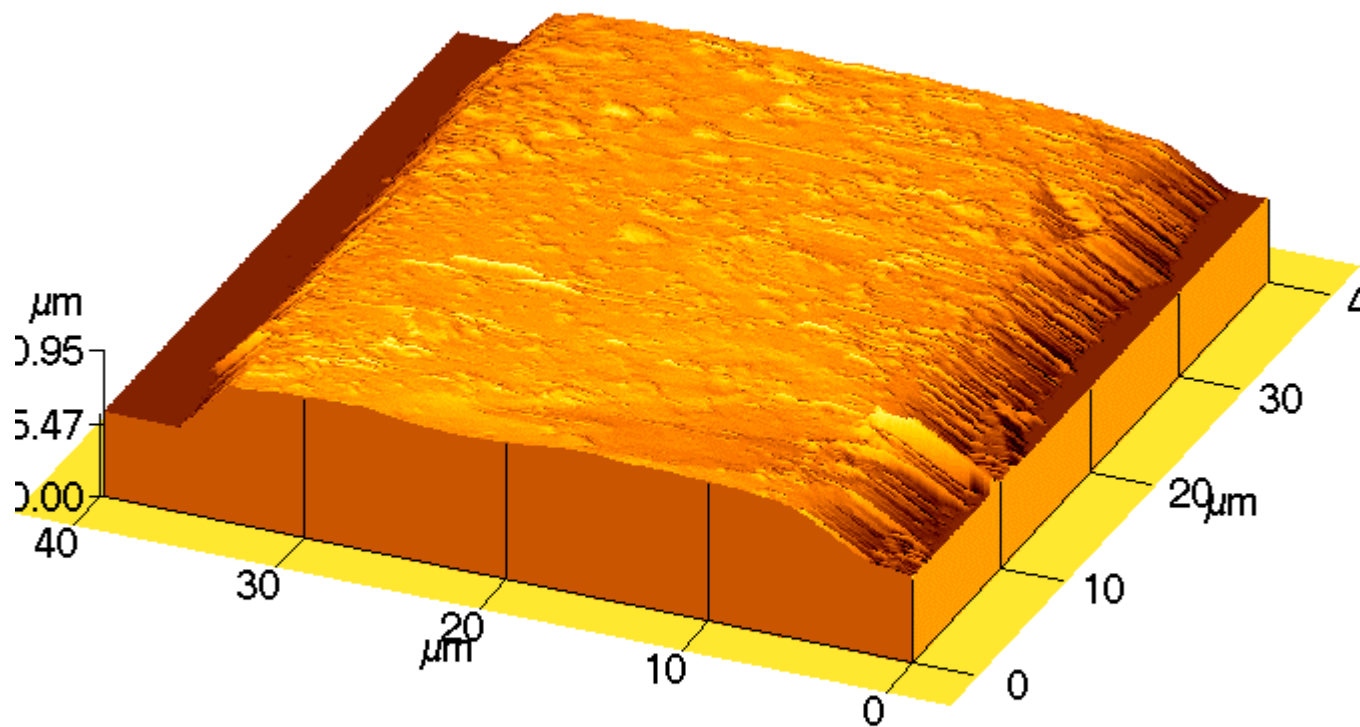
Figure 14 shows the tip of a copper gear tooth. For the three parts listed, this sidewall surface was the smoothest. SEM analysis showed that the copper gear is covered with what appears to be a polymer film. The roughness measured on this part is likely characteristic of this film and not the LIGA copper surface. The sidewall surfaces of both Ni parts were similar and exhibited comparable roughness numbers. Figure 15 shows the sidewall of a Ni Sandia Logo (NM). Roughness is present on this surface at two scales. Undulations with a period of $\sim 5\mu\text{m}$ perpendicular to the thickness direction can be seen in the $20\mu\text{m}$ scan. This type of feature was noticed on all the Ni LIGA parts, and may be due to a roughness in the patterned PMMA resist. A much smaller (nm scale) roughness

Fig. 14 Tip of a Cu gear (CA) tooth: AFM image.
A location such as this can be seen in Fig. 2b.

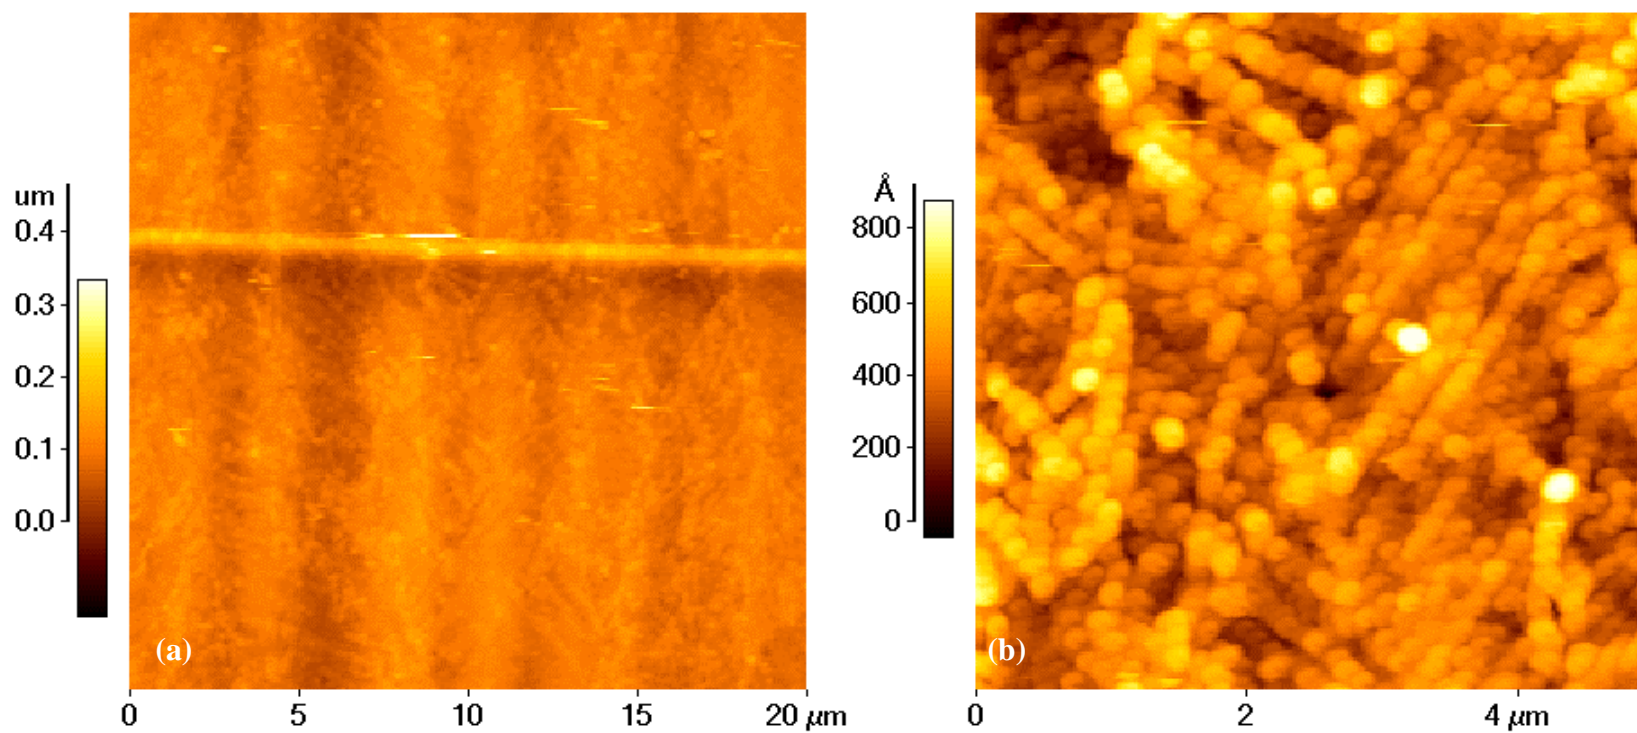
can be seen in the 5 μ m scan. This roughness is the columnar structure seen in the SEM (Figure 10). Because these features are on the order of the tip radius they are convoluted with the tip shape in the image.

Fig. 15 Sidewall morphology of a LIGA Ni (NM) SANDIA LOGO: AFM images. (a) showing surface undulations, (b) showing the columnar structure seen in Fig. 10. Distortion in the image is an effect of tip convolution.

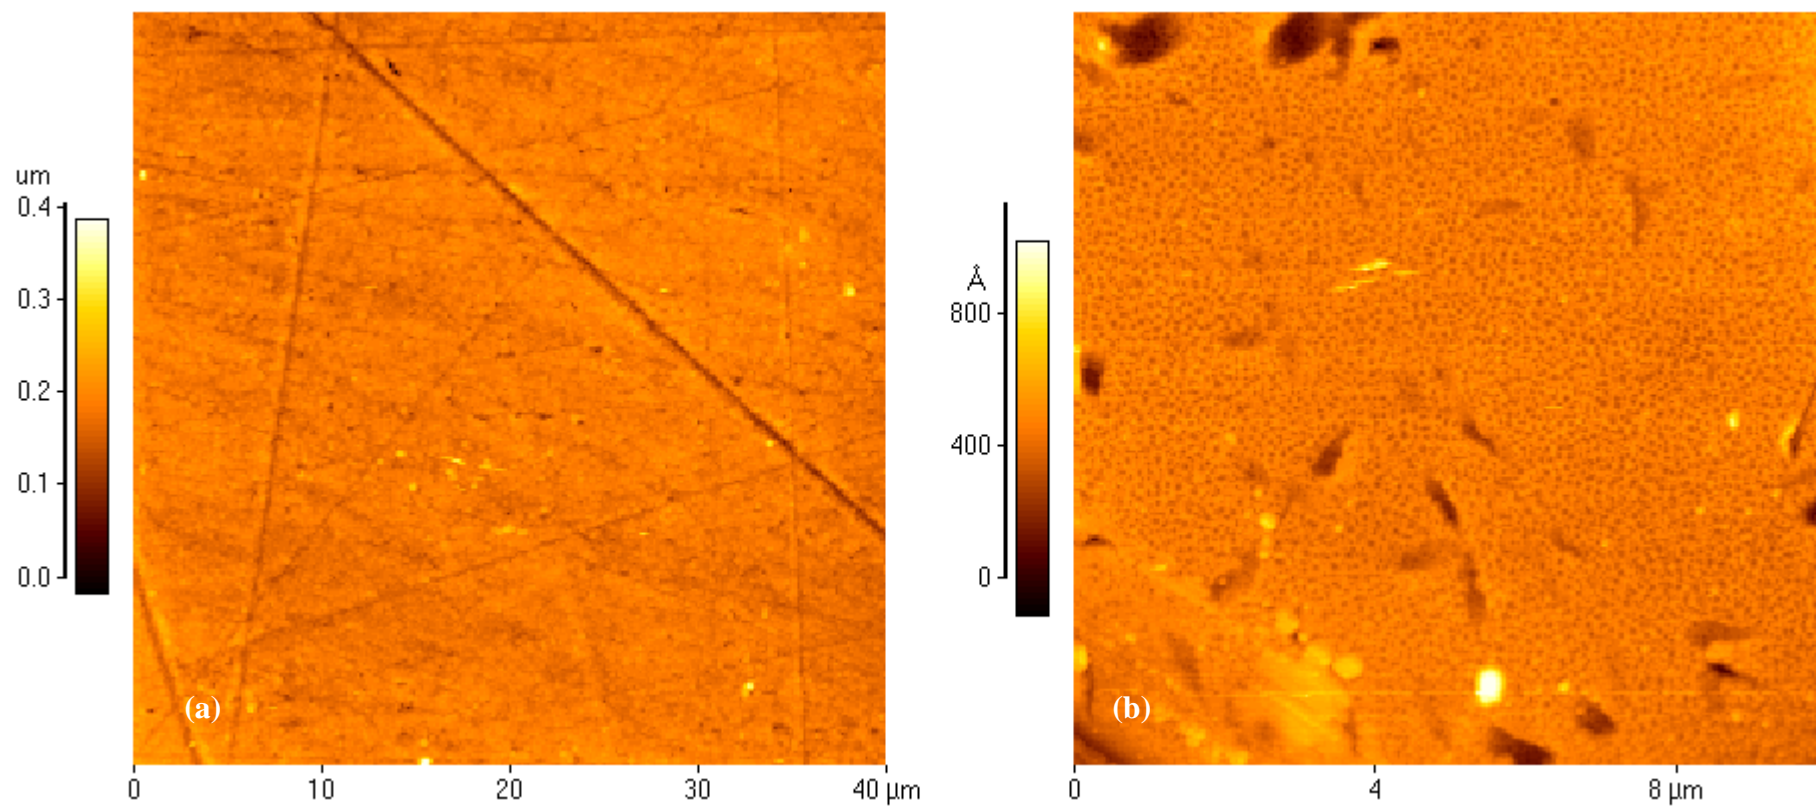
Figure 16 shows typical lapped and release surfaces of Ni LIGA parts. Although considerable scratches can be seen on the lapped surfaces, their RMS roughness suggests that the scratches are not very deep. The release surfaces appear to be more uniform than the lapped surfaces, however, the roughness data suggests that the features on this surface are quite deep. The roughness of the lapped and release sides of the copper parts is large (order 1-10 μ m). Again, this is thought to be characteristic of the polymer film covering the surface of these parts, and not the copper itself. Interestingly, roughness data for this film suggest that it is smooth on the sidewall and rough on the lapped and release surfaces. The large roughness seen on the lapped and release surfaces is characteristic of holes in the film, debris on the film surface, and not the film itself (see SEM image Fig. 5b).

Fig. 16 AFM images of typical lapped and release Ni surfaces.
(a) Lapped surface of Ni Sandia Logo, (b) Release surface of Ni square.
